Allan's Landscaping/Allan's Disposal Services Ltd.

777 60<sup>th</sup> Street West  
Comprehensive Development Review 2024

Report – 17 January 2025

PINTER & Associates Ltd.  
710A 48<sup>th</sup> Street East  
Saskatoon, SK  
S7K 3Y8  
Project #: 3084- 6

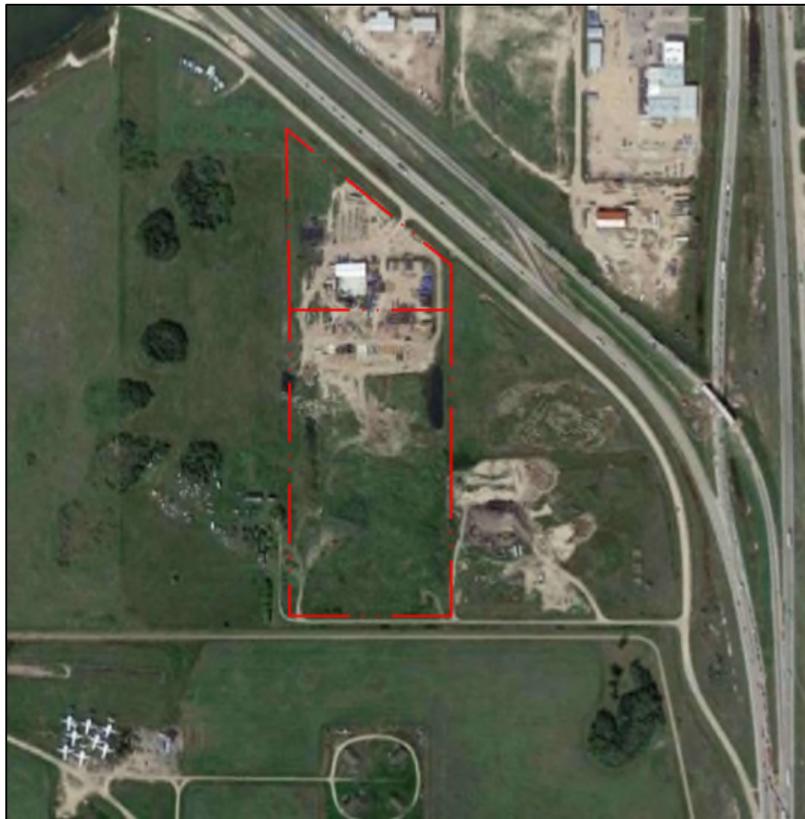
**Figure 3: Aerial Site view**

The property consists of two legal parcels (surface parcel no. 120821981 & 120822005) which have been parcel tied to function as a single property. The combined area of the property is 10.578 hectares (26.139 acres).

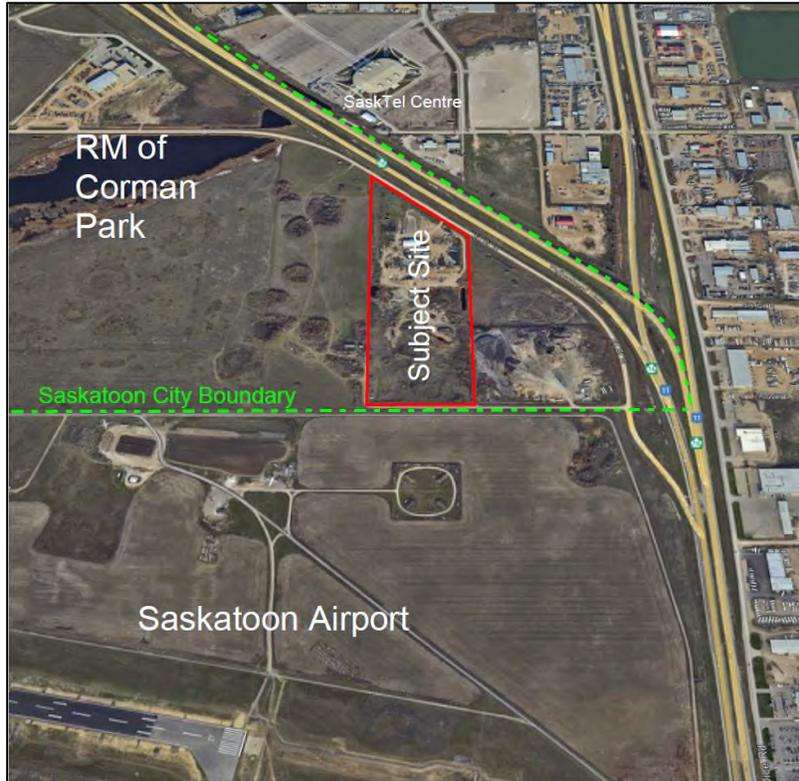
**Figure 4: Surrounding Land use**

The subject property is situated in the northeast corner of the Quarter Section 17-37-05-W3M, directly north of the corporate limits of City of Saskatoon. To the north of the property is bordered by an existing service road running parallel to Highway 16. To the east, it is adjacent to a commercial property, Highways 11 & 16, and the city boundary. To the west lies an abandoned homestead and agricultural land. To the south is the Saskatoon John G. Diefenbaker International

Airport. Figure 4 represent the site location.

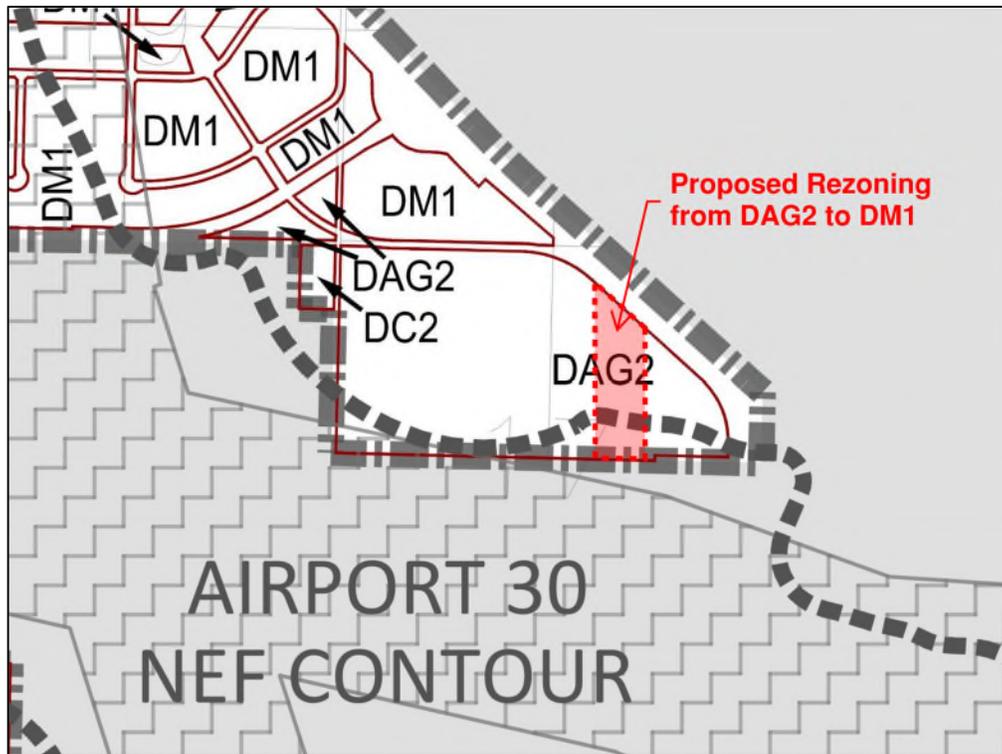
Figure 5: Rezoning Map

Figure 5 is an illustration of the requested zoning amendment. The applicant seeks to change a zoning designation from DAG2 – Agricultural District 2 to DM1 – Light Industrial District 1.

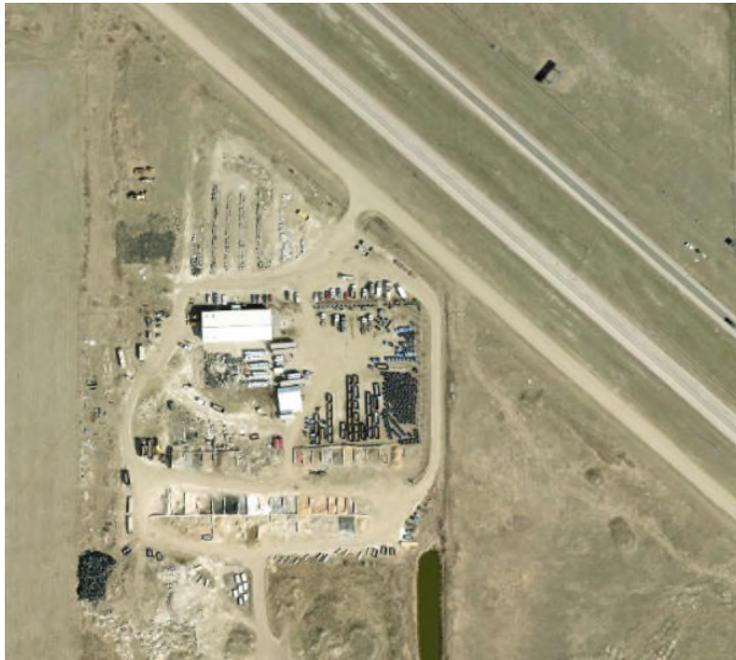
**Figure 6:Site Access**

The site is currently accessed through 60<sup>th</sup> Street West, an existing service road within the RM of Corman Park. The 60<sup>th</sup> Street West roadway is connected to Highway 16 within the city limits. For a site map detailing the access point in relation to the city boundaries, please refer to Appendix L.

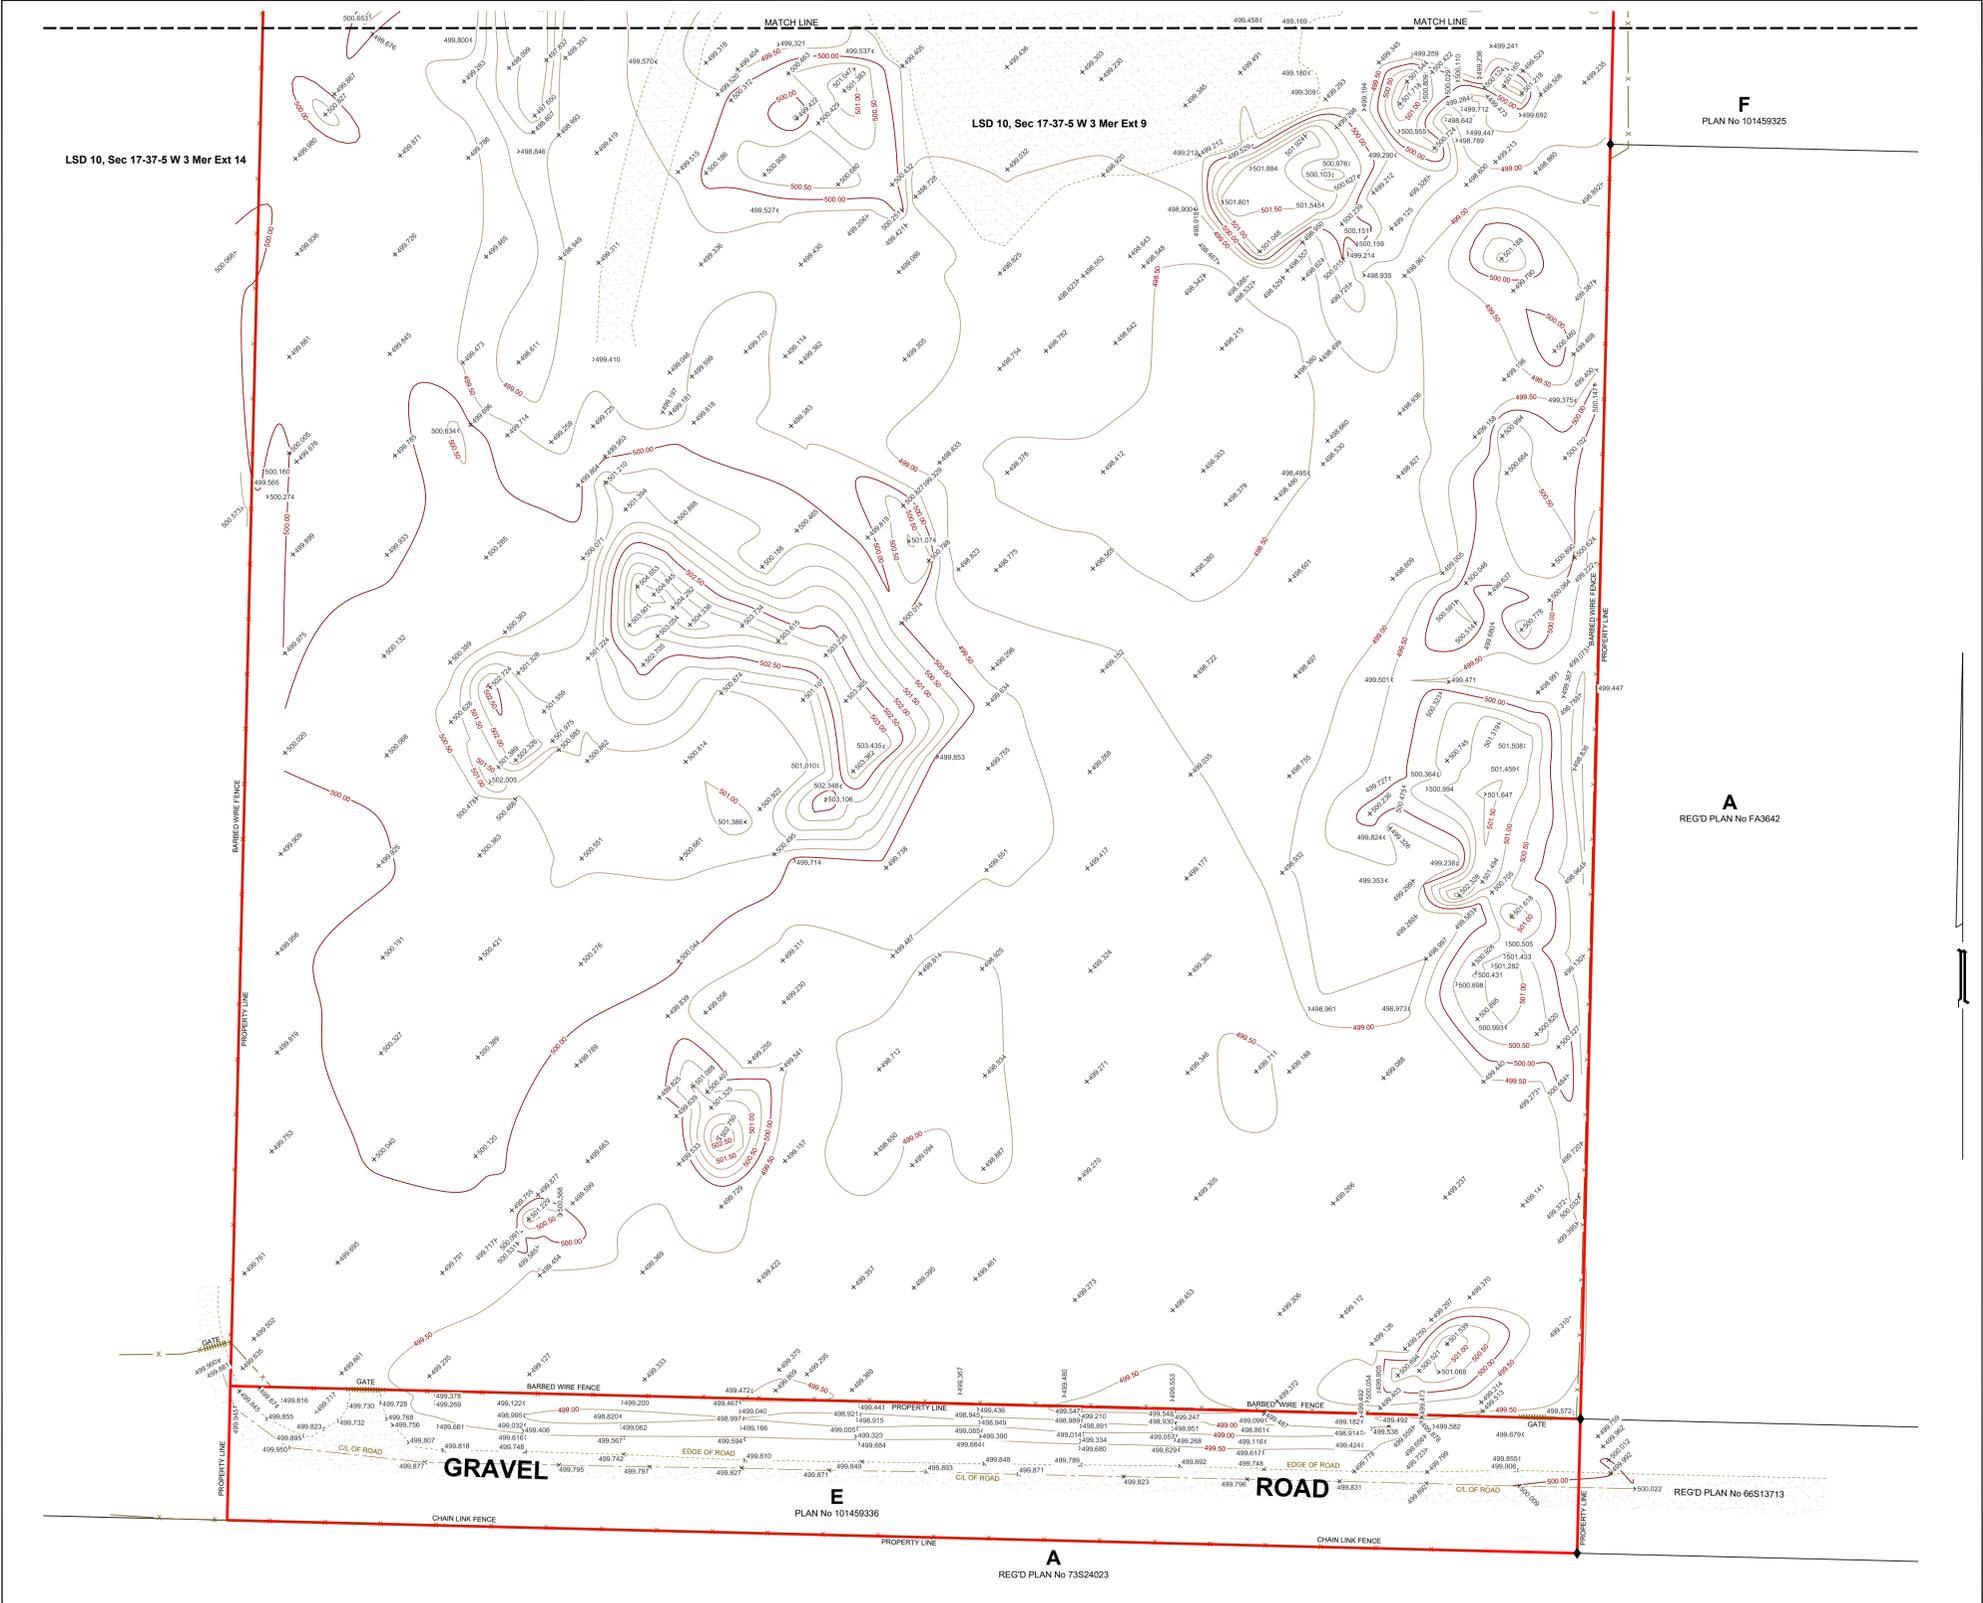
**PLAN SHOWING**  
**TOPOGRAPHICAL SURVEY**  
**OF**  
**LSD 10 & LSD 15, SEC 17, TWP 37, RGE 5, W3 Mer**  
**AND PARCEL E, PLAN No 101459336**  
**RM OF CORMAN PARK No 344**  
**SASKATCHEWAN**  
**SCALE 1:500**

ISC Parcel Boundary drawings can be found in Appendix B detailing the parcel dimensions. A topographic Survey was conducted by Midwest surveys to capture the existing topography of the site and is delivered in the form of a drawing in Appendix C.

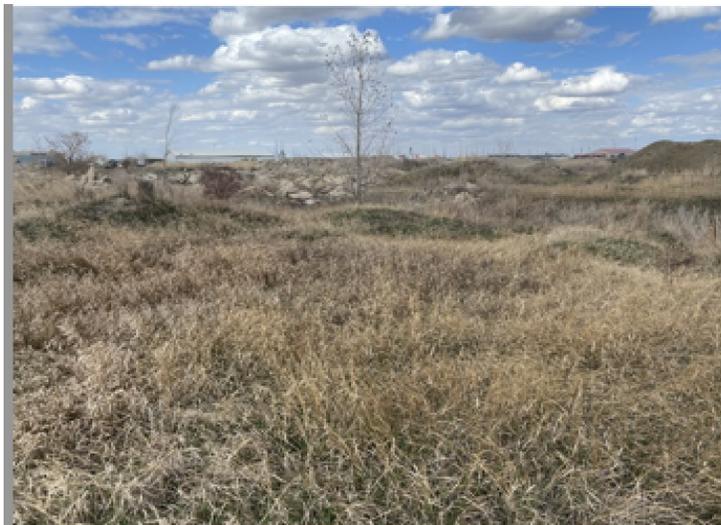
*Photo 5: The majority of the southern area of the Site has had fill and construction materials deposited on it at one time.*

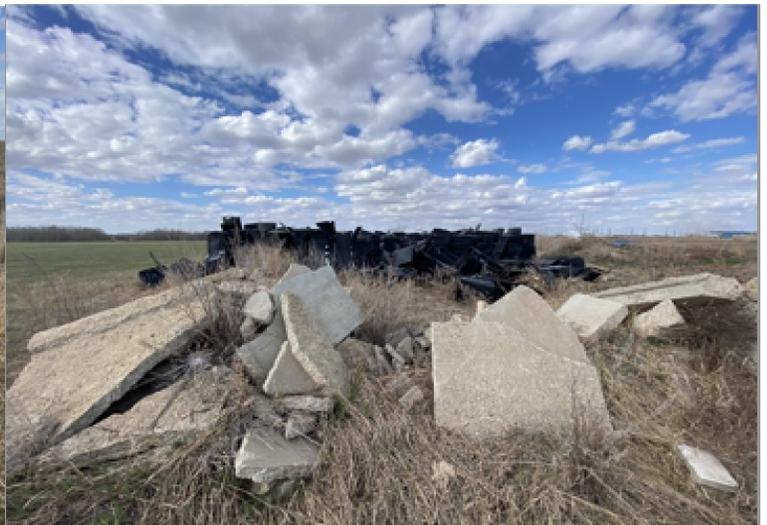
*Photo 6: Concrete slab material. Note the storage of City garbage bins in the background. The adjacent pasture land can be seen in the left hand side of the photograph.*

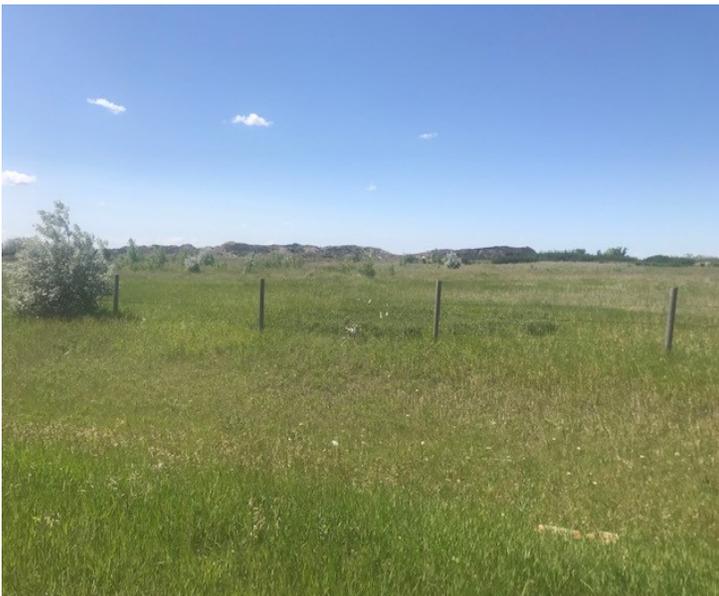
*Photo 11: Vegetated piles of fill deposited on the Site years earlier. (See Figures 3 & 4 in Appendix A).*

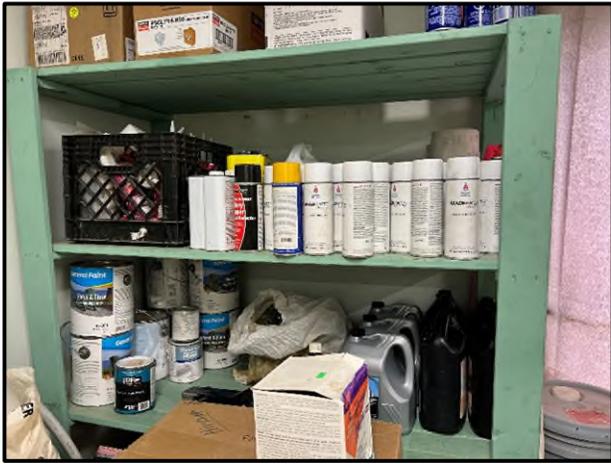
Photo 1: Various cleaners, aerosols and paints were observed on a wooden shelving unit within a storage room.

Numerous containers of industrial cleaners, cans of paint, aerosols, and automotive fluids were observed in a cleaning room of the Subject Property building (Photo 1). The containers ranged in size from approximately 3.0 L to 16.0 L. The items were stored on a wooden shelving unit. The stored items appeared to be contained in their original packaging and no evidence of leaks or spills was observed associated with the stored items.

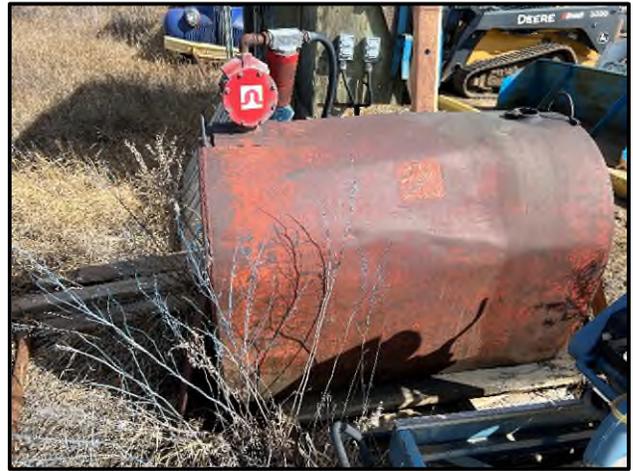
Photo 2: A slip tank was observed near the west region of the Subject Property building.

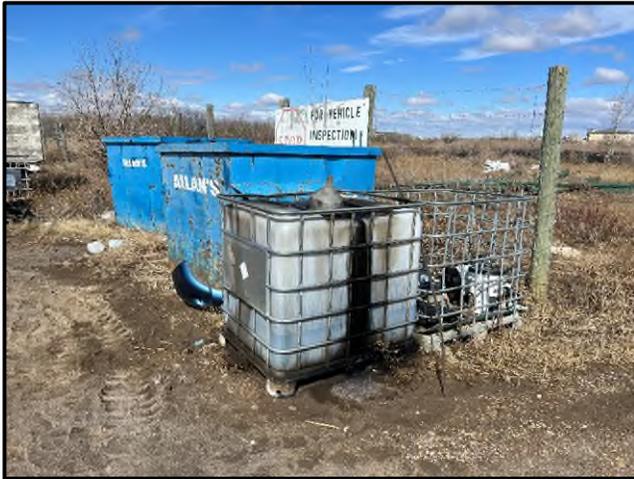
Photo 3: A storage tote was observed in the west region of the property, note staining and stressed vegetation, facing northwest.

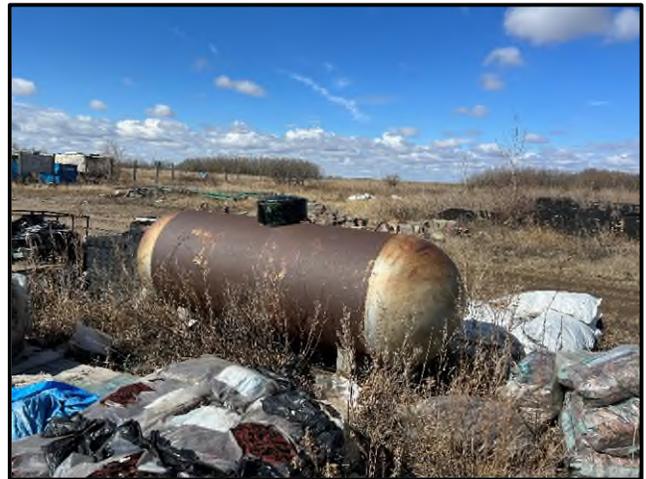
Photo 4: A propane bullet tank was observed in the north region of the Subject Property, facing northwest

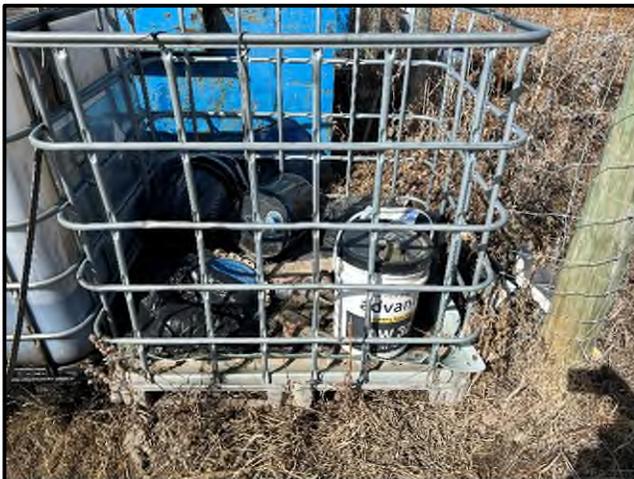
A propane bullet tank was observed in the north region of the Subject Property (Photo 4). The propane bullet tank appeared to be situated on a metal stand above the gravel surface. Evidence of rusting and chipped paint was observed on the bullet tank. Punctures were not observed on the bullet tank.

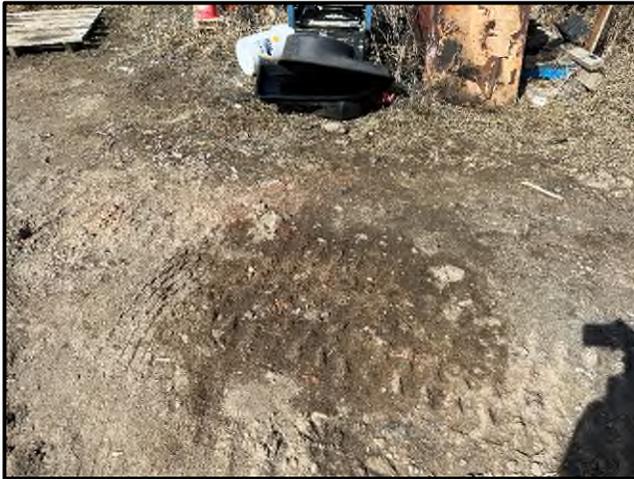
Photo 9: Discoloured gravel was observed throughout the storage yard.

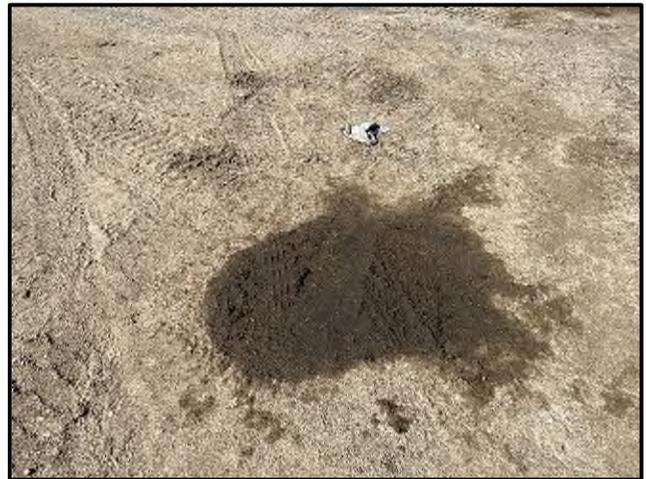
Photo 10: Discoloured gravel was observed throughout the storage yard.

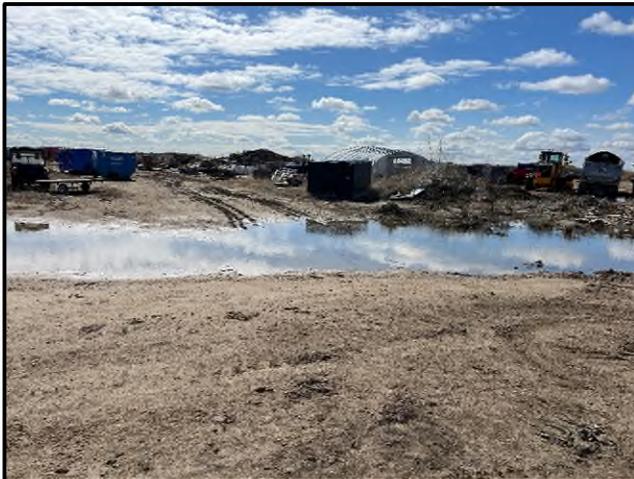
Areas of standing water were observed throughout the Subject Property (Photo 11). In addition, a slough is located along the east region of the Subject Property (Photo 12).

Photo 11: Standing water was observed throughout the Subject Property storage yard, facing east.

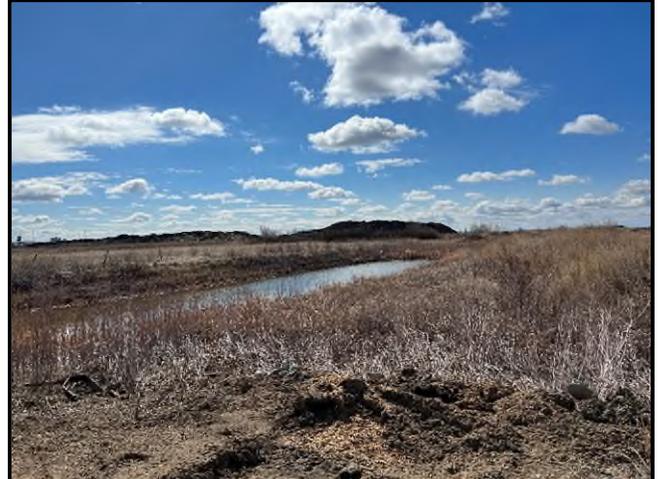
Photo 12: A slough was observed along the east region of the Subject Property, facing southeast.

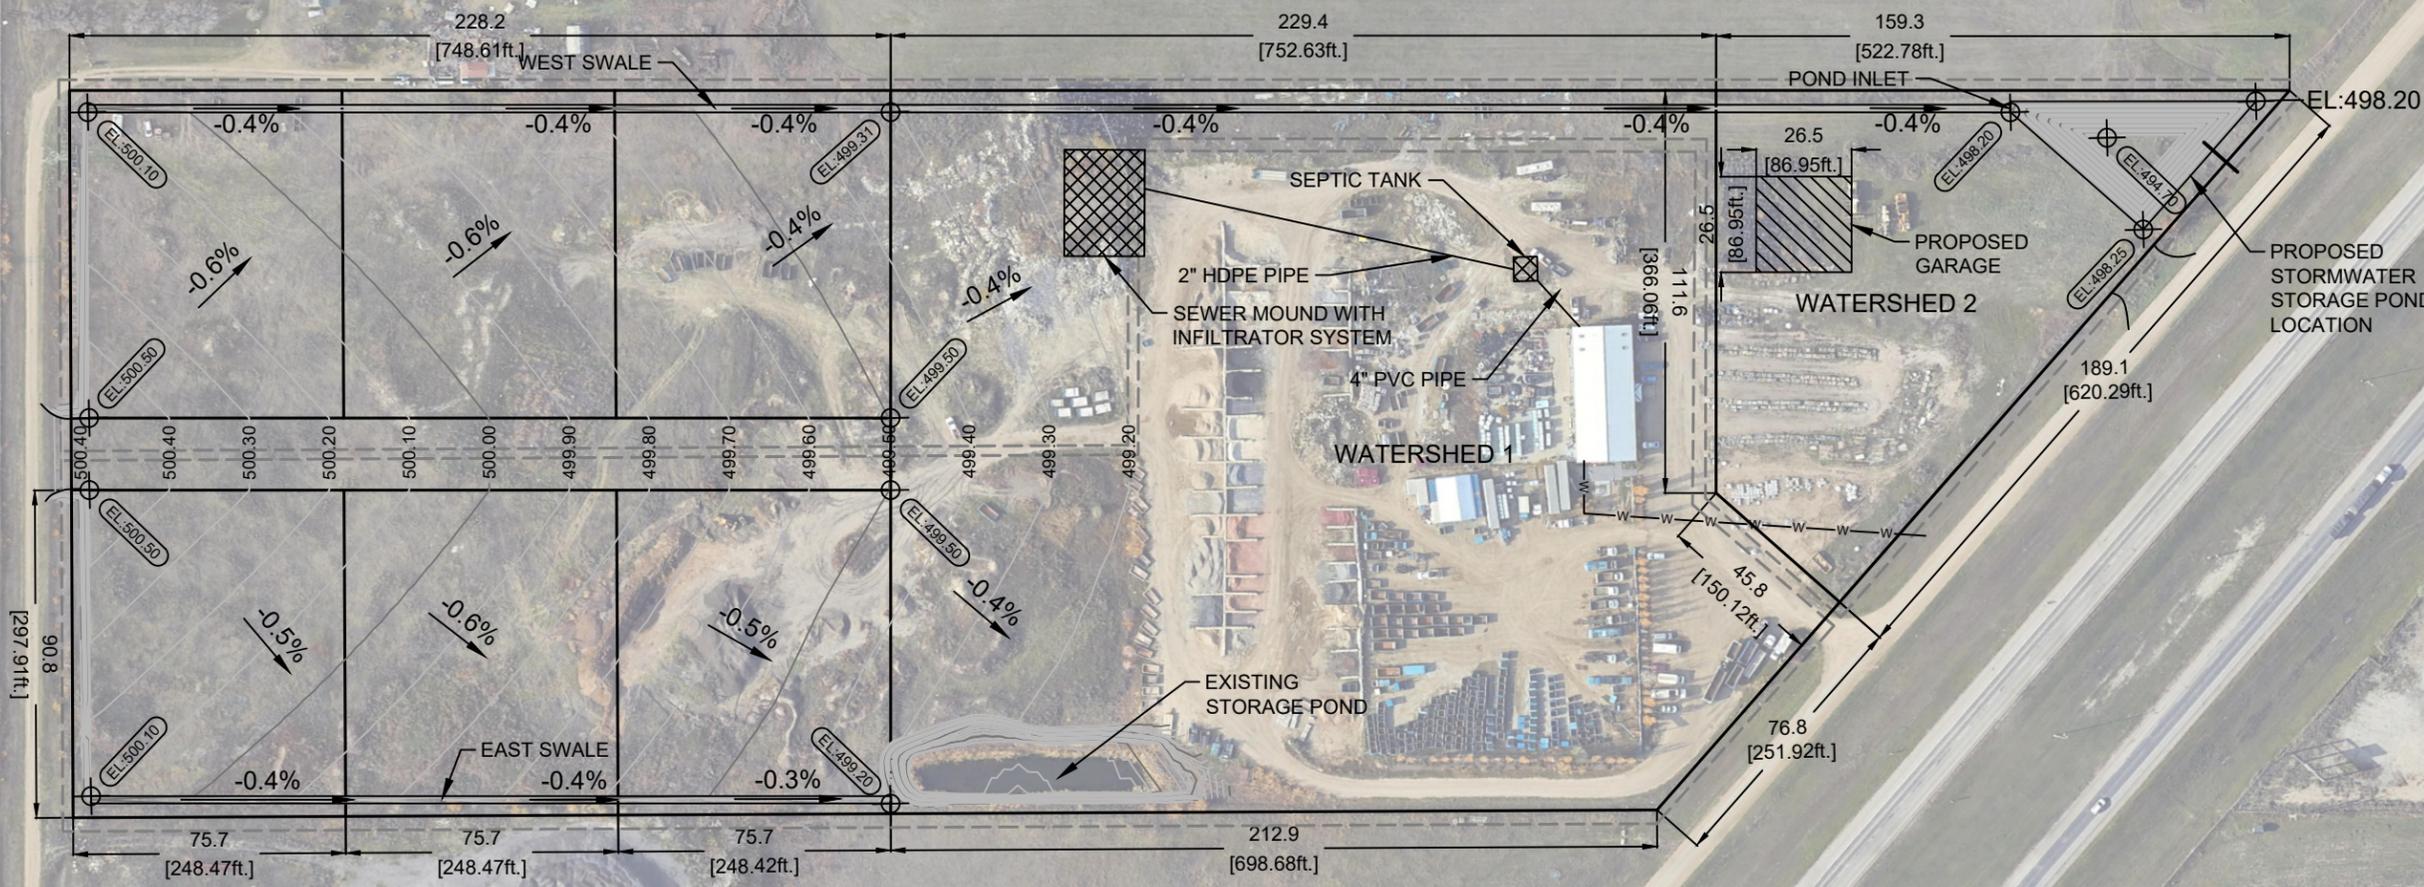
As part of the proposed improvements, the development plan recommends the construction of a new stormwater pond at the northeast corner of the property to manage the increased runoff from anticipated additional development. Additionally, two drainage swales, graded at 0.3% to 0.4%, will be constructed along the eastern and western boundaries of the site. These swales will direct runoff northward and connect the existing and proposed stormwater storage ponds.

For further details, please refer to Appendix J, which provides the drainage plan illustrating the necessary grading of the site and proposed development, proposed stormwater storage pond, and the proposed drainage swales. Additionally, Appendix K contains the drainage report, outlining the design recommendations and technical specifications for the proposed drainage system.

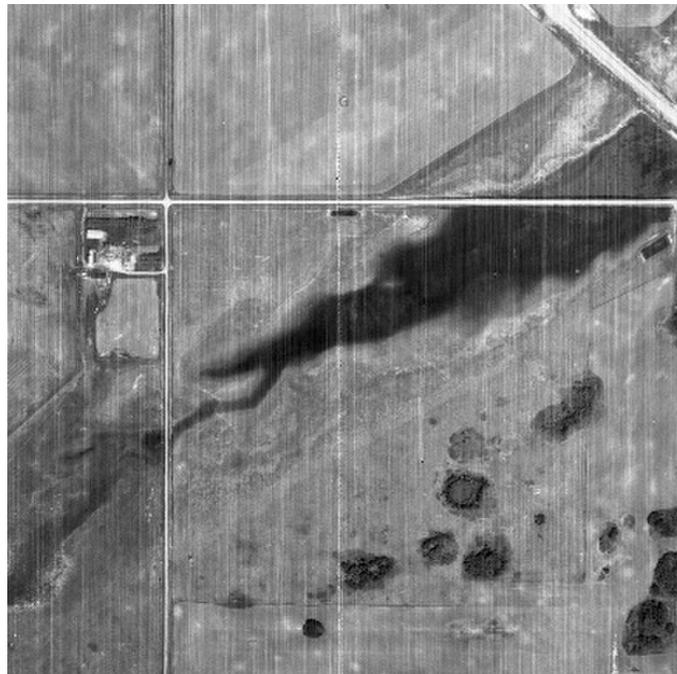
LSD 10, Sec 17-37-5 W 3 Mer Ext 14

PINTER assessed and reviewed available satellite/aerial imagery for the Site. An examination of Google Earth Pro's (Ver. 7.3.6.9345) found that the Site's early available historical satellite image was taken in 1974 (as shown in **Figure 2.1**). The photo shows the Site was covered by vegetation and plants at the time which represents the pre-development stage.

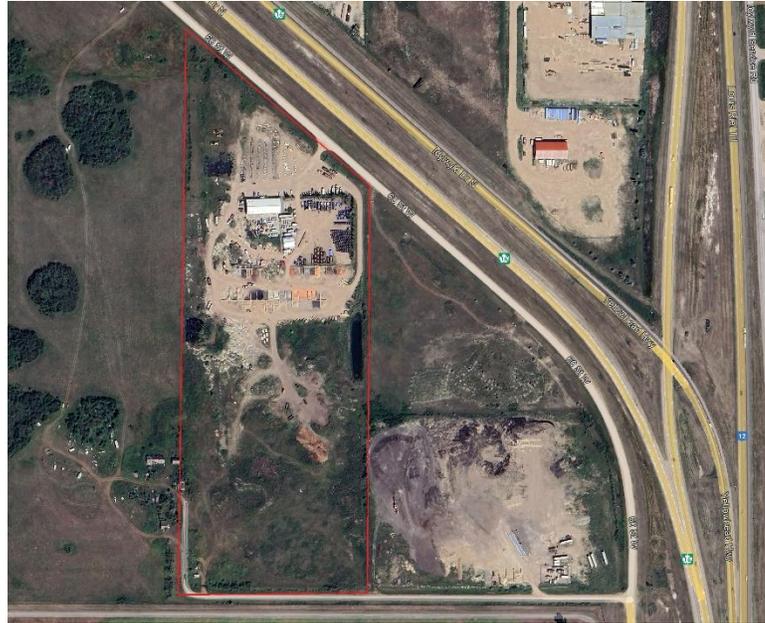
**Figure 2.2 Current Site Conditions**

Then the photo dated 2015 at **Figure 2.2** showed the changes in land development from the land's natural topography to the development of the existing facility on the Site. The photo also showed the landscape after the facility's construction, with a large waterbody located in the southeast corners of the developed area.
